Manhole Inspection Summary

Manhole # S45MM_039MH

Inspection ☐ Is Incomplete Rating: **3) Fair**

Insp Date: **3/25/08 11:10 AM**

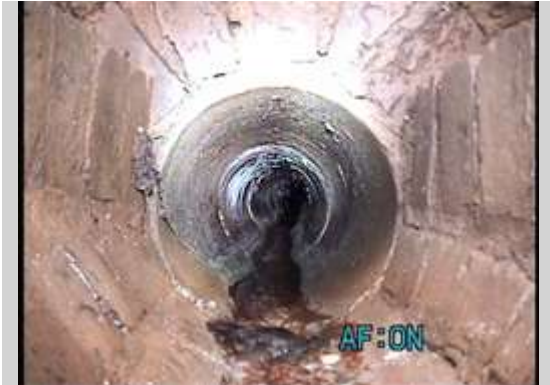
12 O'Clock Outflow

8 in. Circular Gravity Sewer
Pipe Out @ 12 O'Clock

Pipe Height: **8.4** (in.) Rod and Bar (Angled)
Pipe Material: **Clay** ☐ Pipe Lined
Invert Depth: **6.90** (ft.) Flow Characteristics: **Fast**
Deposits: ☒ None ☐ Mud ☐ Gravy ☐ Debris ☐ Grease
Silt Depth: (in.) Deposits Extent:
Infiltration: **None** Pipe Seal Cond: **Sound**
